COMMUNITY CENTRE PATTERSON LAKES, VIC

BBG TEAMS: VIC Major Projects & Linx Restoration
PROJECT TYPE: Fire makes safe, rectification and rebuild
PROJECT SIZE: 6400m2
BUILDING TYPE: Community Centre
PROJECT VALUE: \$1.039m

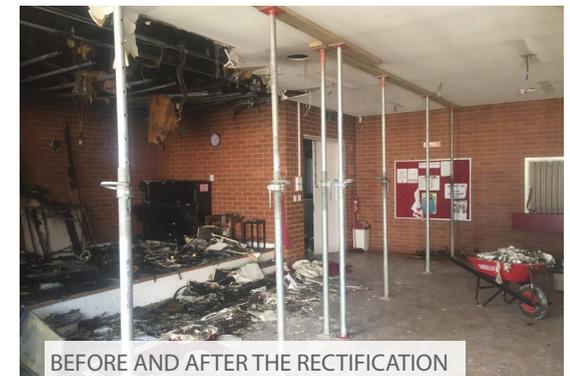
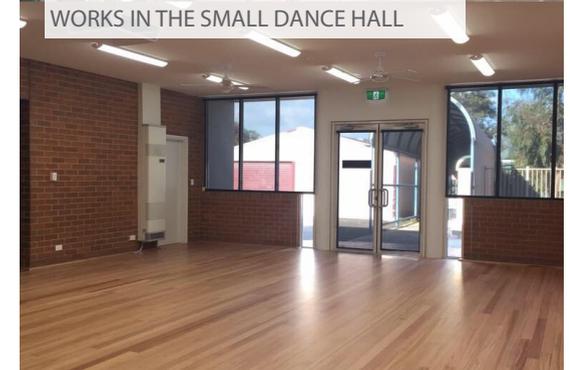
BEFORE AND AFTER THE RECTIFICATION WORKS IN THE SMALL DANCE HALL

At the same time, the centre took the opportunity to engage Bay Major Projects to carry out a number of upgrades to their commercial kitchen and install a sprung timber floor in their dance hall. The flooring required concrete grind to remove excess glue before installation of 85sqm of a sprung timber floor to the small dance hall. Associated ramp upgrades works were also undertaken to transition existing ramps to the new sprung floor levels and allow for full disabled access.
