SHOOTING RANGE SHELTER

LITTLE RIVER, VIC

BBG TEAM: Bay Major Projects
PROJECT TYPE: Demolition & Rebuild
PROJECT SIZE: 172m x 6m x 2.5m
BUILDING TYPE: Steel Shelter
PROJECT VALUE: \$454k

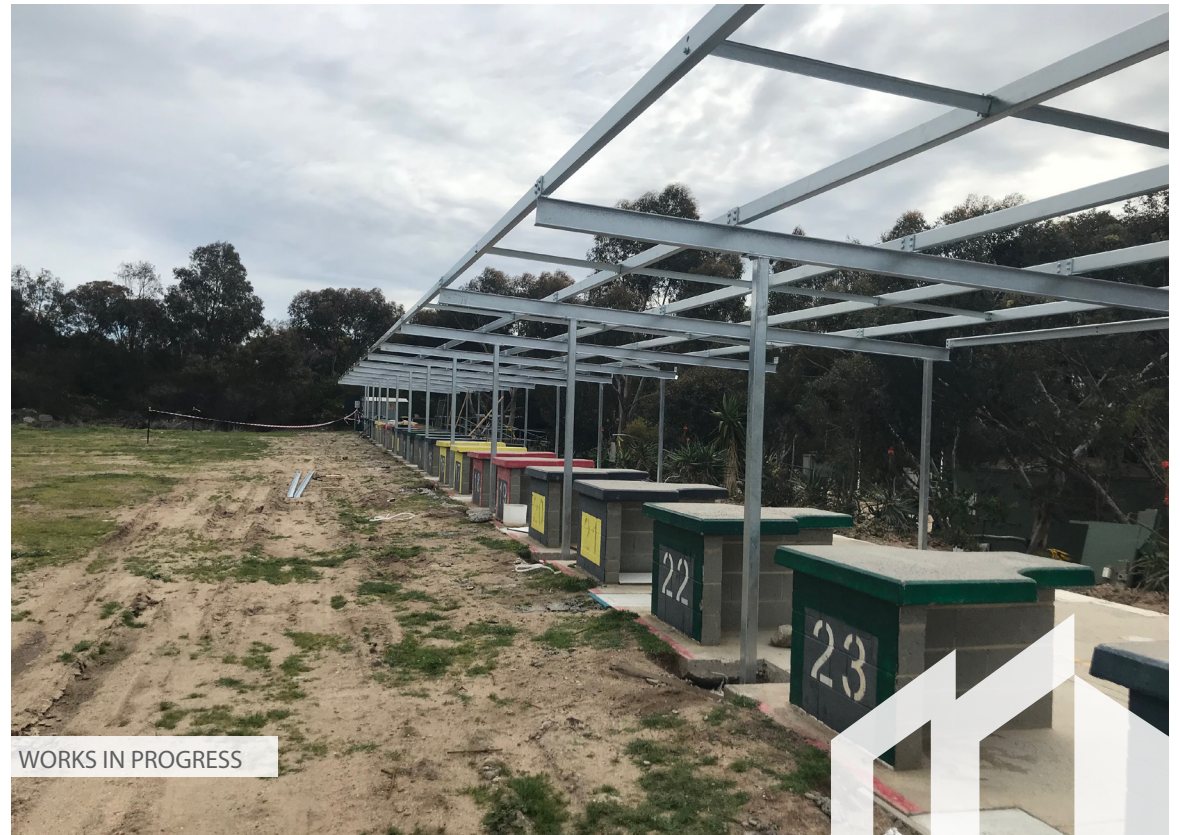
WORKS IN PROGRESS

The Bay Building Major Projects team were called in to coordinate the demolition and rebuild of this steel shooting shelter. The existing structure was torn apart by strong winds, storm damage and failed to meet wind loads.

Bay Building Services worked with multiple consultants, architects, geotech, hydraulic and structural engineers to solve compliance issues and site constraints such as soil conditions. The main frame structure required redesign as the existing one failed to meet the wind loads. The structure's footing also had to be upgraded as the structure was built over fill. This classed the soil as "P" (problem). Drainage upgrades were also required as the previous water-run off was feeding to water tanks that did not have sufficient overflow or runoff system. A hydraulic engineer was engaged to design a completely new drainage system, including charged downpipe drains to the water tanks.
