## COMMERCIAL COMPLEX

ALEXANDRIA, NSW

BBG TEAM: NSW Major Projects  
PROJECT TYPE: Storm rectification works  
PROJECT SIZE: 6400m<sup>2</sup>  
BUILDING TYPE: Commercial complex - 4 high profile tenancies  
PROJECT VALUE: \$1.75m

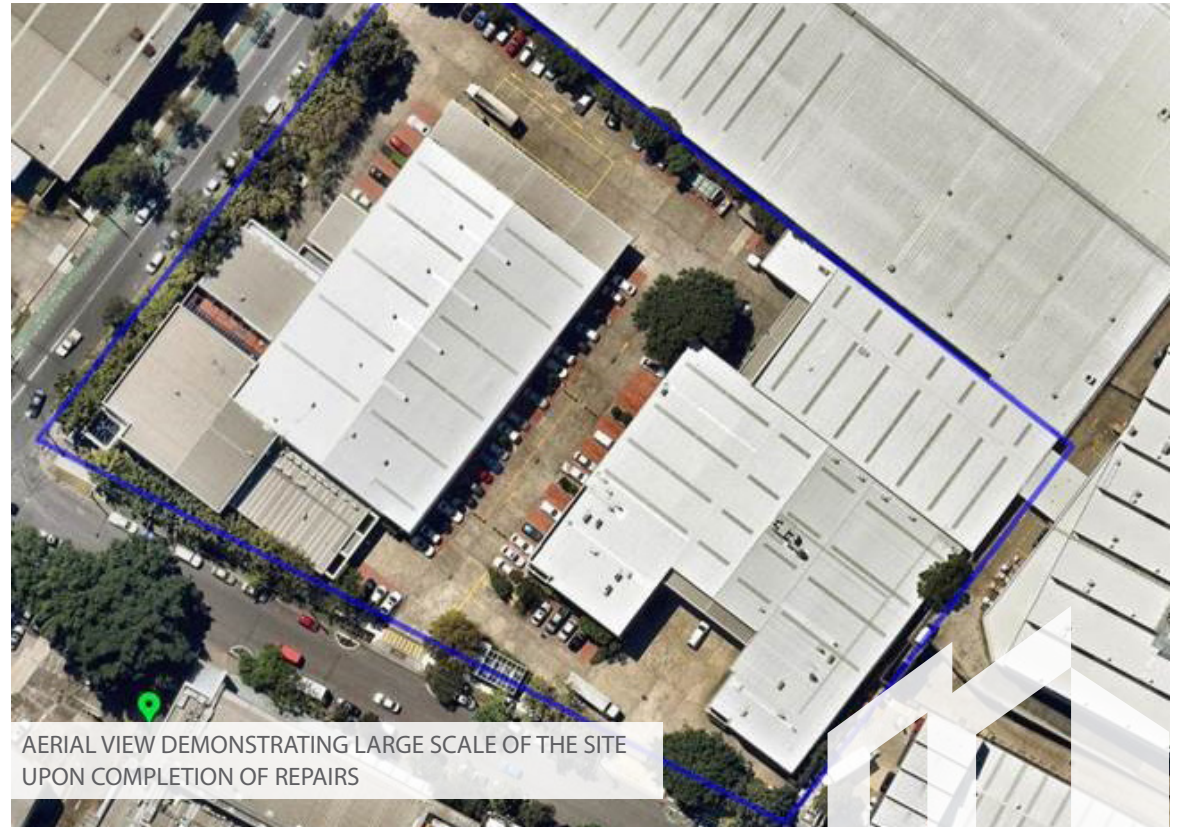
AERIAL VIEW DEMONSTRATING LARGE SCALE OF THE SITE UPON COMPLETION OF REPAIRS

During a severe thunderstorm in April 2015, this commercial estate in Alexandria was battered by large hailstones causing extensive damage to its four high profile tenancies. As a result, 6400m<sup>2</sup> of damaged roofing, inclusive of all associated flashings, insulation blanket and wire, had to be replaced.

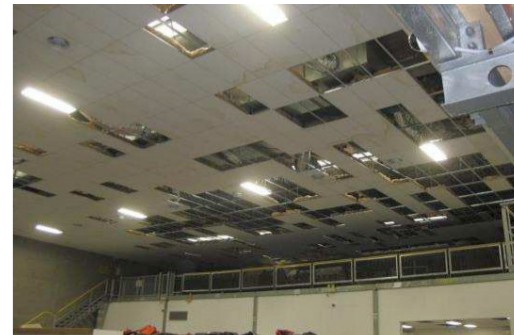
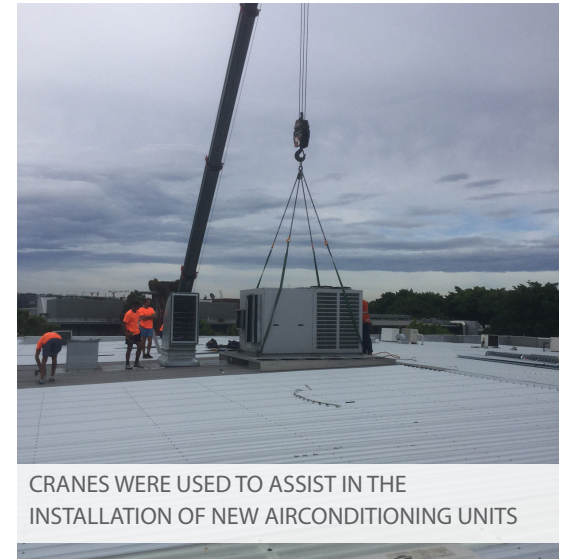
CRANES WERE USED TO ASSIST IN THE INSTALLATION OF NEW AIRCONDITIONING UNITS

To facilitate the roof removal and replacement, all roof mounted services had to be disconnected and either set aside for reinstatement or replaced as required. Apart from roof repairs, a significant component of the scope included the removal and replacement of four large rooftop air conditioning packages and numerous condensers, all of which had to be carried out using a 50t crane.
