WEST MALING HOUSE

Penshurst, NSW

BBG TEAM: Bay Building Services
 PROJECT TYPE: Heritage Listed Restoration
 PROJECT SIZE: 105m²
 BUILDING TYPE: Heritage Listed House
 PROJECT VALUE: \$180k

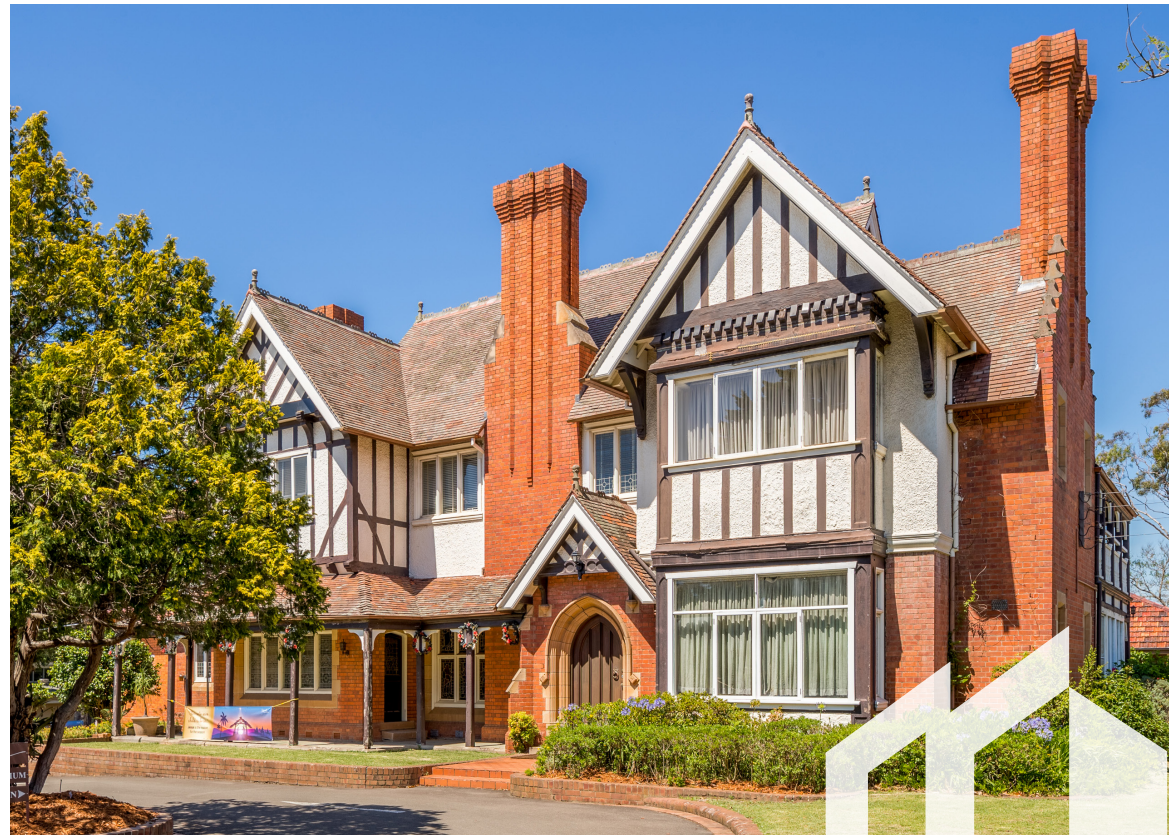
The heritage listed West Maling house in Penshurst was damaged following severe storms in New South Wales. This beautiful Tudor Style Heritage Building was built circa 1888. During the storms a number of the original roof tiles became dislodged and due to the age of the building, it sustained internal water damage as well as damage to some of the roof battens.

The team worked quickly to erect five board wide scaffolding for access and storage during repairs. The roof was done in sections and each part of the rectification was carefully documented. Every care was taken by the team to ensure that the original slate roof tiles were stored, sorted by type, style and thickness so that they could be reused. They then quickly installed the oregon battens and sarking to ensure the roof was water tight. The team reinstalled the removed tiles as per traditional fixing, using clout head nails and interlocking methods to sections of roof as detailed in the heritage impact statement. Where existing tiles could not be used, replacement tiles were sourced from the UK and blended in.

At the same time additional works were carried out to the chimney flashings and guttering as well as internal patching and plastering to the house. Works were completed within a month in late 2017 and all works arranged so that the centre remained fully operational throughout.

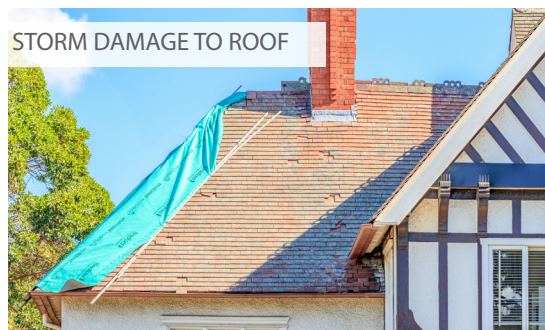
STORM DAMAGE TO ROOF
