COMMUNITY CENTRE PATTERSON LAKES, VIC

BBG TEAMS: VIC Major Projects & Linx Restoration
PROJECT TYPE: Fire makes safe, rectification and rebuild
PROJECT SIZE: 6400m2
BUILDING TYPE: Community Centre
PROJECT VALUE: \$1.039m

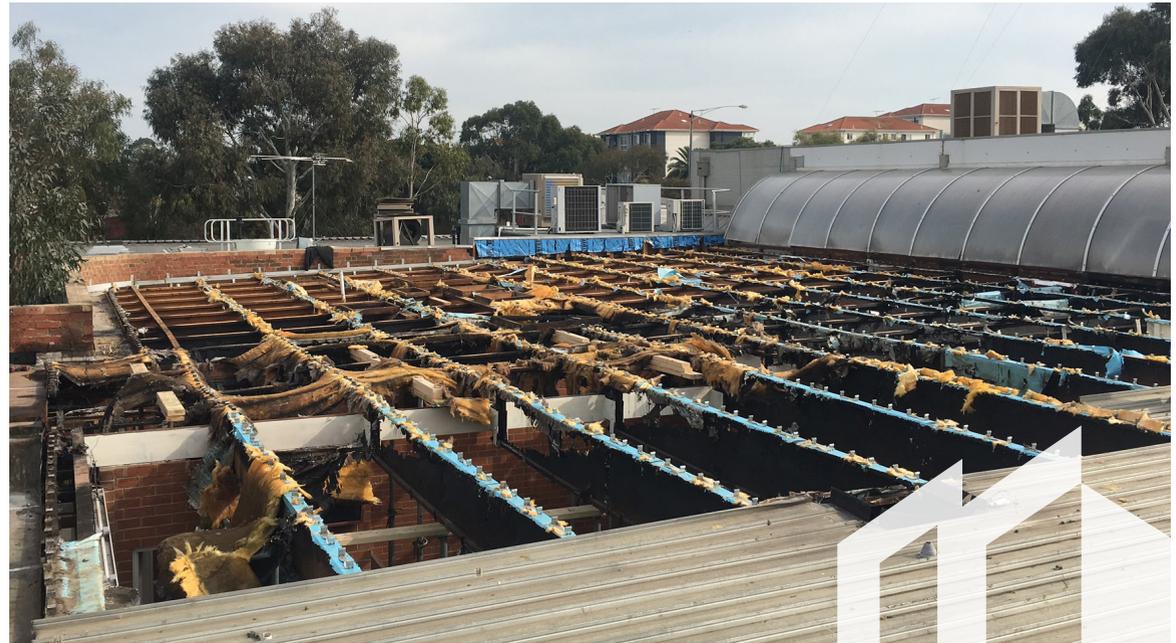
On Wednesday March 22nd 2017, Patterson Lakes Library and Community Centre suffered extensive fire damage. Fifty CFA crew members attended the scene where the blaze was believed to have started in the roof of the community centre, with this area consequently suffering the most damage. The library also sustained smoke and water damage.

Extensive make safe works were carried out on site and completed within days of the fire. Linx Restoration Services completed water extraction, drying and mitigation to carpets, flooring and substrates throughout in the days following the fire to prevent further loss. They removed debris, packed out affected contents and undertook a detail clean of the library.

The Major Projects team installed temporary power to the affected areas to facilitate the reinstatement. They removed all damaged electrical fittings and cabling; removed damaged ceilings and plaster walls throughout the affected area as well as propped the roof frame to rear hall area to satisfy the emergency order.

The make safe also included the supply and installation of new switchboards to reinstate power to the library, foyer, amenities, meeting rooms, communication tower and car park as well as the reinstatement of hot and cold water to the library and meeting rooms.

The team carried out aerial post fire clean to the main hall/gym area, disconnected wall furnaces and affected plumbing fittings. They also secured the box gutter and skylight to prevent further water entry to building.

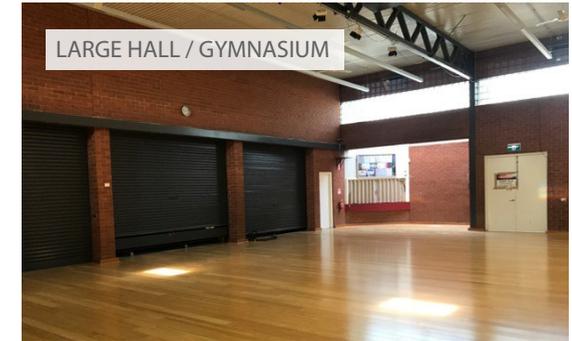
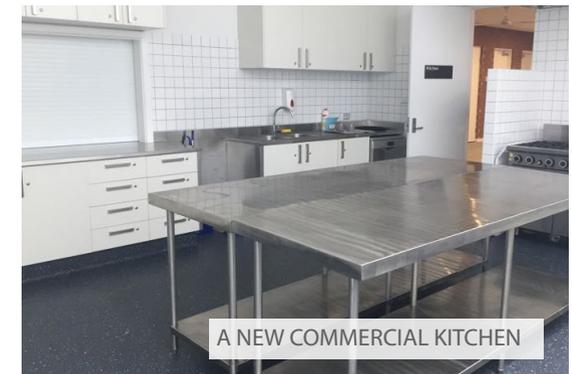
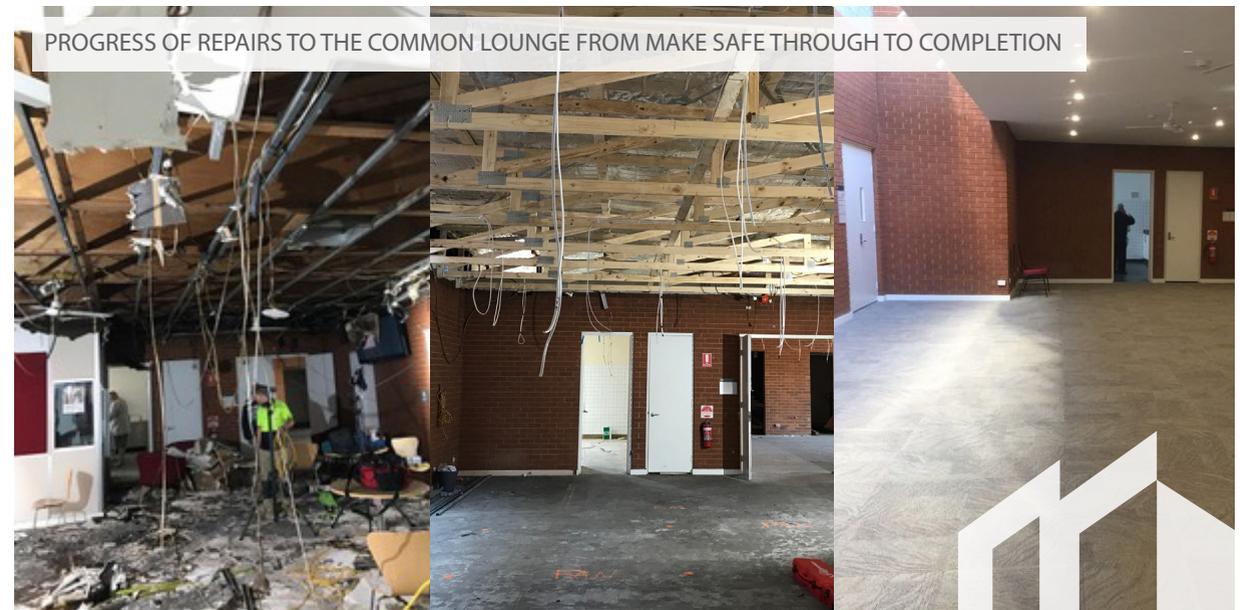
Stage 4 was works to the most critically damaged section of the building including the dance hall, storerooms, toilets, community lounge, office and commercial kitchen. This was also the most technically challenging part of the reinstatement works. The roof framing required engineering redesign, recomputation and permits. Bay Major Projects used cranes for building materials and the roof plant. Elevated work platforms were constructed to replace and reconstruct the charred roof frame as well as for replacement of bullnose corflute skylights. As part of the reinstatement works the team removed and replaced 340sqm of roof sheeting followed by replacement ceilings and painting throughout.

As part of this stage, Linx Restoration Services completed a detailed clean of the existing roof frame, ceiling linings and brickwork. Linx used a technique of ice blasting on the brickwork to remove smoke staining and rejuvenate the existing brickwork as an alternative to more costly repainting and replacement.

At the same time, the centre took the opportunity to engage Bay Major Projects to carry out a number of upgrades to their commercial kitchen and install a sprung timber floor in their dance hall. The flooring required concrete grind to remove excess glue before installation of 85sqm of a sprung timber floor to the small dance hall. Associated ramp upgrades works were also undertaken to transition existing ramps to the new sprung floor levels and allow for full disabled access.
