## SAFETY ALERT 001 – POOL FENCING

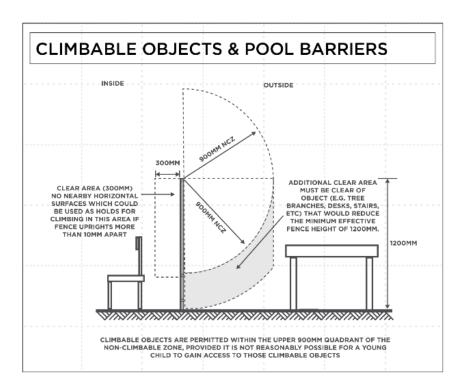
Pool fencing have a non-climbable zone (NCZ) of 900mm from the top of the pool fence. This zone is to be kept free of climbable objects. Pool gates are self-closing and are not to be left in the open position via propping the gate open.

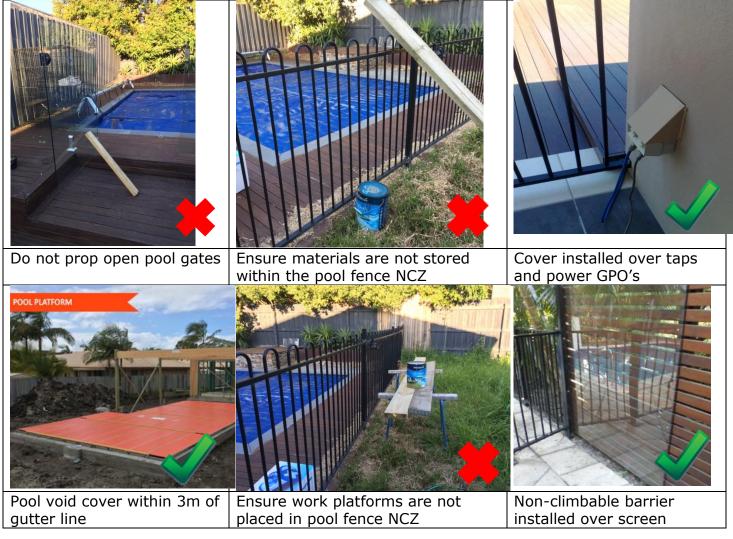
When undertaking works near to a pool fence we must ensure that we do not create climbable objects within the pool fence NCZ. The following are some items to consider:

- Do not leave ladders unattended or unsecured as they can be used to climb over the pool fence
- Set up work trestles outside of the 900mm no go zone
- Do not lean, stack, or leave materials within the 900mm pool NCZ as they can become climbable objects

Consideration will also need to be given to the type of work we are doing near to the pool fence. If we are repairing or replacing taps, electrical points, timber screening, gates etc we need to ensure these items do not become climbable objects within the pool fence NCZ.

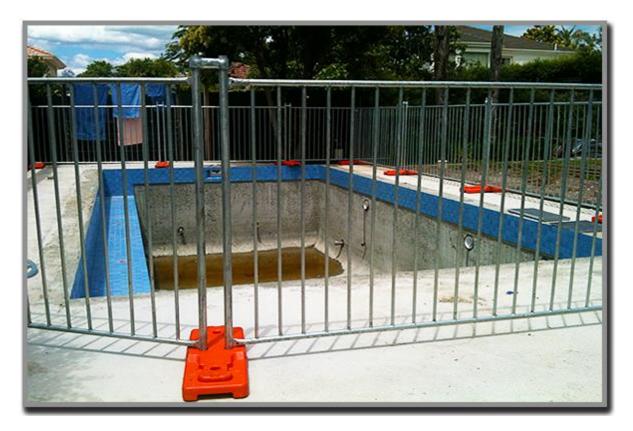
Where pool fencing has been damaged during a claimable event it is important that we assess if the fencing can be repaired and returned to it's original state as quick as possible. If this is not possible then a compliant temporary pool fence can be installed until rectification works are completed. Some insurers may require approval prior to installing such fencing. The following is an example of a compliant temporary pool fence:
