CASE STUDY

SOMERVILLE MECHANICS INSTITUTE SOMERVILLE, VIC

PROJECT NAME: Somerville Mechnics Institute
PROJECT LOCATION: Somerville, VIC
PROJECT SIZE: 480m²
BBG TEAM: Major Projects Team

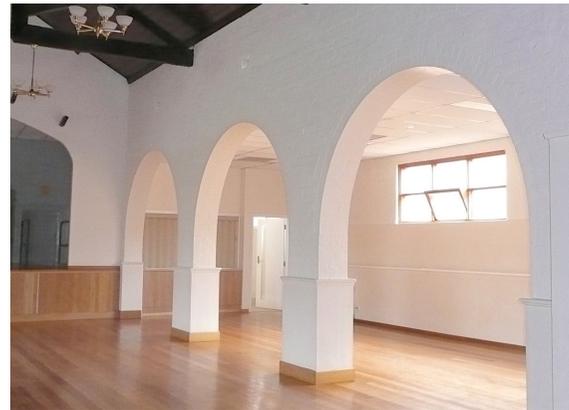
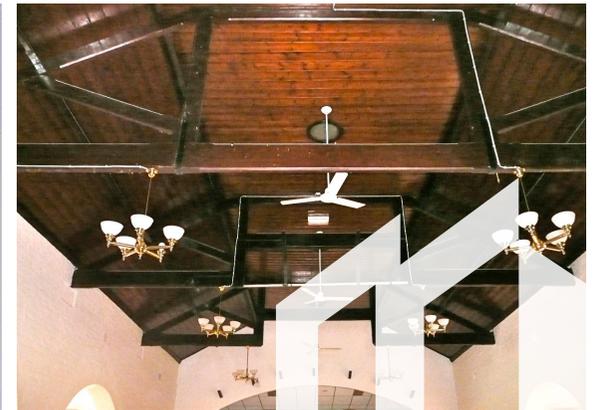
THIS VITAL COMMUNITY HUB REQUIRED CAREFUL AND HISTORICALLY SENSITIVE REPAIR AND RECTIFICATION FOLLOWING DEVASTATING STORM DAMAGE

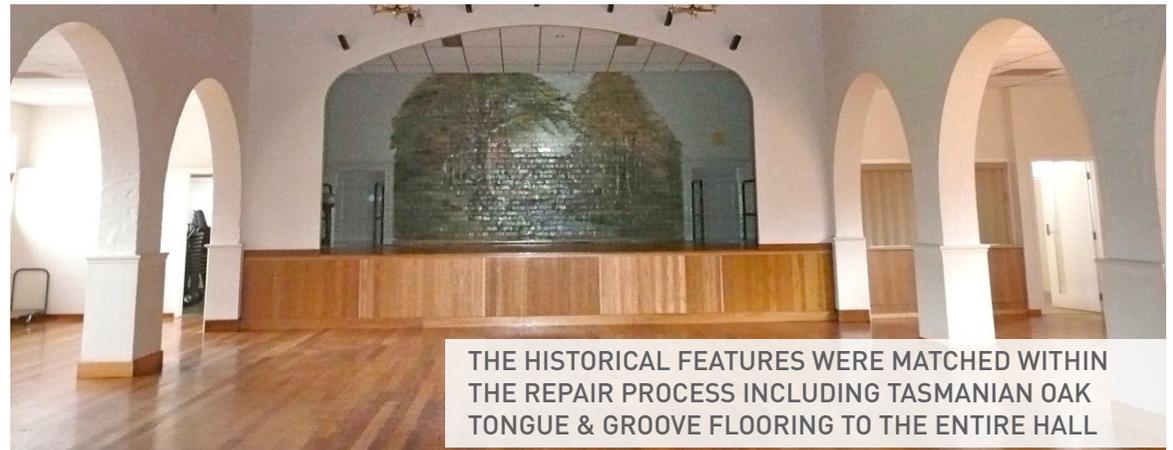
THE HISTORICAL FEATURES WERE MATCHED WITHIN THE REPAIR PROCESS INCLUDING TASMANIAN OAK TONGUE & GROOVE FLOORING TO THE ENTIRE HALL

Major works at the hall involved replacing the entire roof structure. Within the building, works were carried out to repair and replace the timber lined ceiling, feature linings and mouldings with historical overlay to match existing, as well as full flooring replacement to the stage, and hall in matching heritage tongue and groove and strip flooring of Tasmanian Oak. The entire hall was also repainted, all electrics were upgraded, air conditioning units were replaced, and the external walls re-rendered. Our team matched historical features within the heritage overlay to ensure that all existing historical features were matched in the repairs.
