MOOROOKA SPORTS & COMMUNITY CLUB MOOROOKA, QLD

BBG TEAM: QLD Major Projects
PROJECT TYPE: Storm rectification works
PROJECT SIZE: 2500m²
BUILDING TYPE: Commercial sporting complex
PROJECT VALUE: \$550k

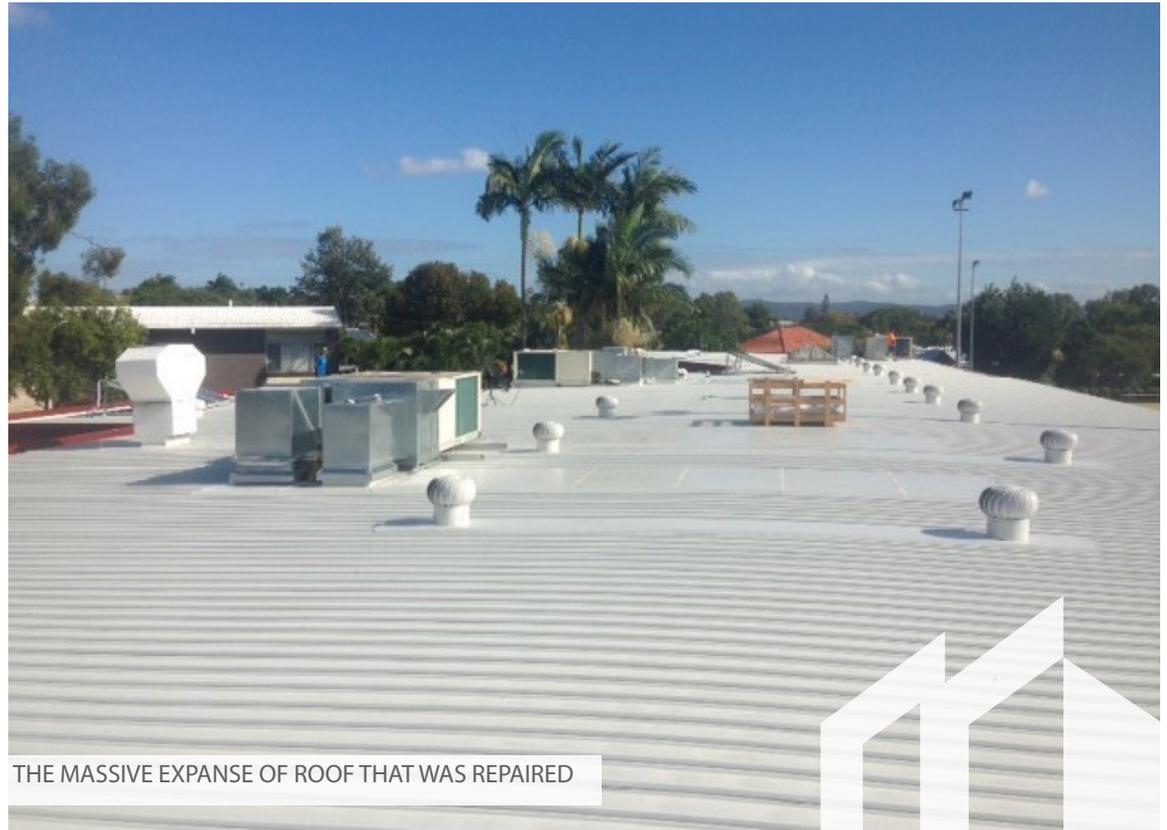
THE MASSIVE EXPANSE OF ROOF THAT WAS REPAIRED

The largest component of the rebuild comprised of roof works, including all associated flashings, gutters and up to 50 whirlybirds. A 30 tonne crane was used to remove and replace the roof, including 10 commercial ducted airconditioning units and 19-metre-long roof sheets. Engineers were brought in as the roof structure needed to be repitched to comply with new standards. Internal works were completed simultaneously with each section of the roof repairs. Acoustic tiling in the restaurant dining room was completely replaced, as well as all ceiling fans. Externally, clocks, flood lights, water tanks and sheds were all replaced, as well as cladding and numerous other external items.

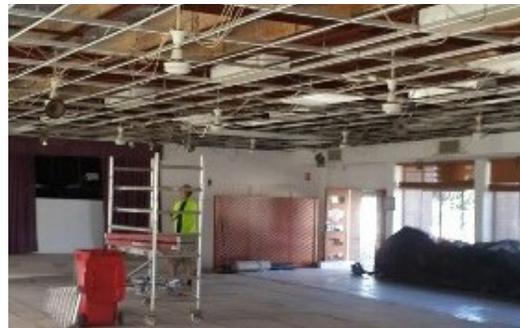
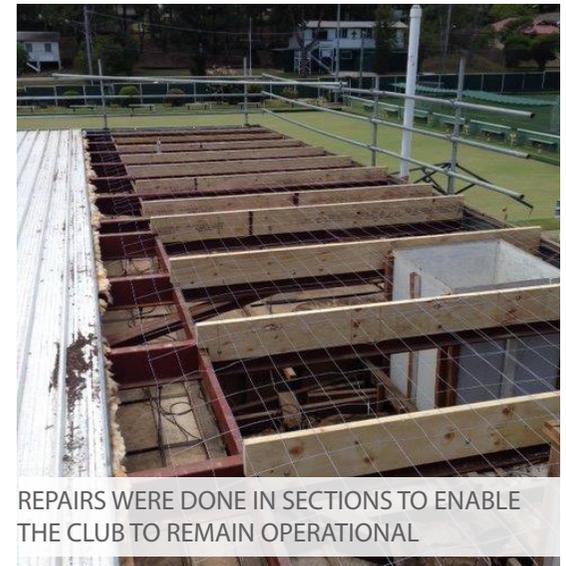
REPAIRS WERE DONE IN SECTIONS TO ENABLE THE CLUB TO REMAIN OPERATIONAL

Appointed by Cunningham Lindsey, our QLD Major Projects team devised a comprehensive plan to enable club operations to continue whilst repairs took place, minimising business interruption. This plan involved reinstatement works being carried section by section to ensure minimal disruption. Prior to any works commencing the team discovered asbestos in the back deck, and carefully carried out its removal and disposal quickly and efficiently.
